# SERVICE PARTS LIST

SPECIFY CATALOG NO. AND SERIAL NO. WHEN ORDERING PARTS		REVISED BULLETIN 54-38-1600	DATE Aug. 2007
<b>9" GRINDER</b>			
CATALOG NO.	<b>6086-20</b>	SERIAL NUMBER	<b>991B</b>
		WIRING INSTRUCTION <b>58-01-1370</b>

**RECALL NOTICE!**  
 See back page for important safety information.

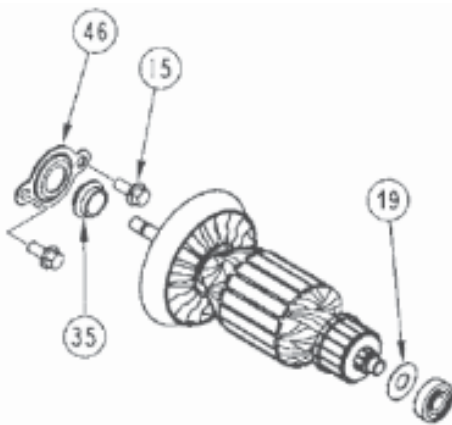
**31-50-1752 Motor Housing Kit** incorporates changes to the shielding of the armature pinion and commutator ball bearings along with the retaining of the pinion ball bearing into the gearcase assembly of 7"/ 9" 15Amp Sander / Grinders - 6080-20, 6081-20, 6082-20, 6086-20, 6088-20 and 6089-20.

Additionally, a change has been made to the motor housing and wiring of the tool. The ATF field coil is now 'hard-wired' with four [4] new leadwire assemblies, see **Wiring Instruction 58-01-1371**. Add 'X' Grease, 49-08-5000 to mag-mate field terminals as need.

<sup>A</sup> Service Note - 'check for slip fit' - mounting of 02-04-1680 Ball Bearing to the armature shaft may require removal of a 0.0001" - 0.0002" from the O.D. of the armature pinion end ball bearing journal - it is recommended to use emery cloth and armature lathe to lightly sand, for a few seconds, removing the material necessary for the pinion shaft to be a 'slip fit through the pinion ball bearing' as it is being held in place in the GearCase by the 44-86-0040 Bearing Retainer.

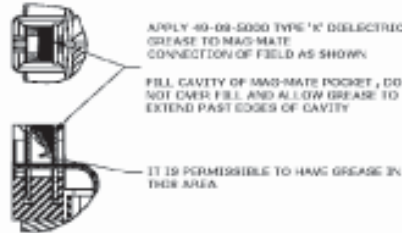
Caution! Do Not overfill the cavity, excess grease can cause a build up of dust / dirt and result in a possible 'shorting-out' or burning at the connection.
