# SERVICE PARTS LIST

SPECIFY CATALOG NO. AND SERIAL NO. WHEN ORDERING PARTS		REVISED BULLETIN 54-38-1600	DATE Aug. 2007
<b>9" GRINDER</b>			
CATALOG NO.	<b>6086-20</b>	SERIAL NUMBER	<b>991B</b>
		WIRING INSTRUCTION <b>58-01-1370</b>

**RECALL NOTICE!**  
 See back page for important safety information.

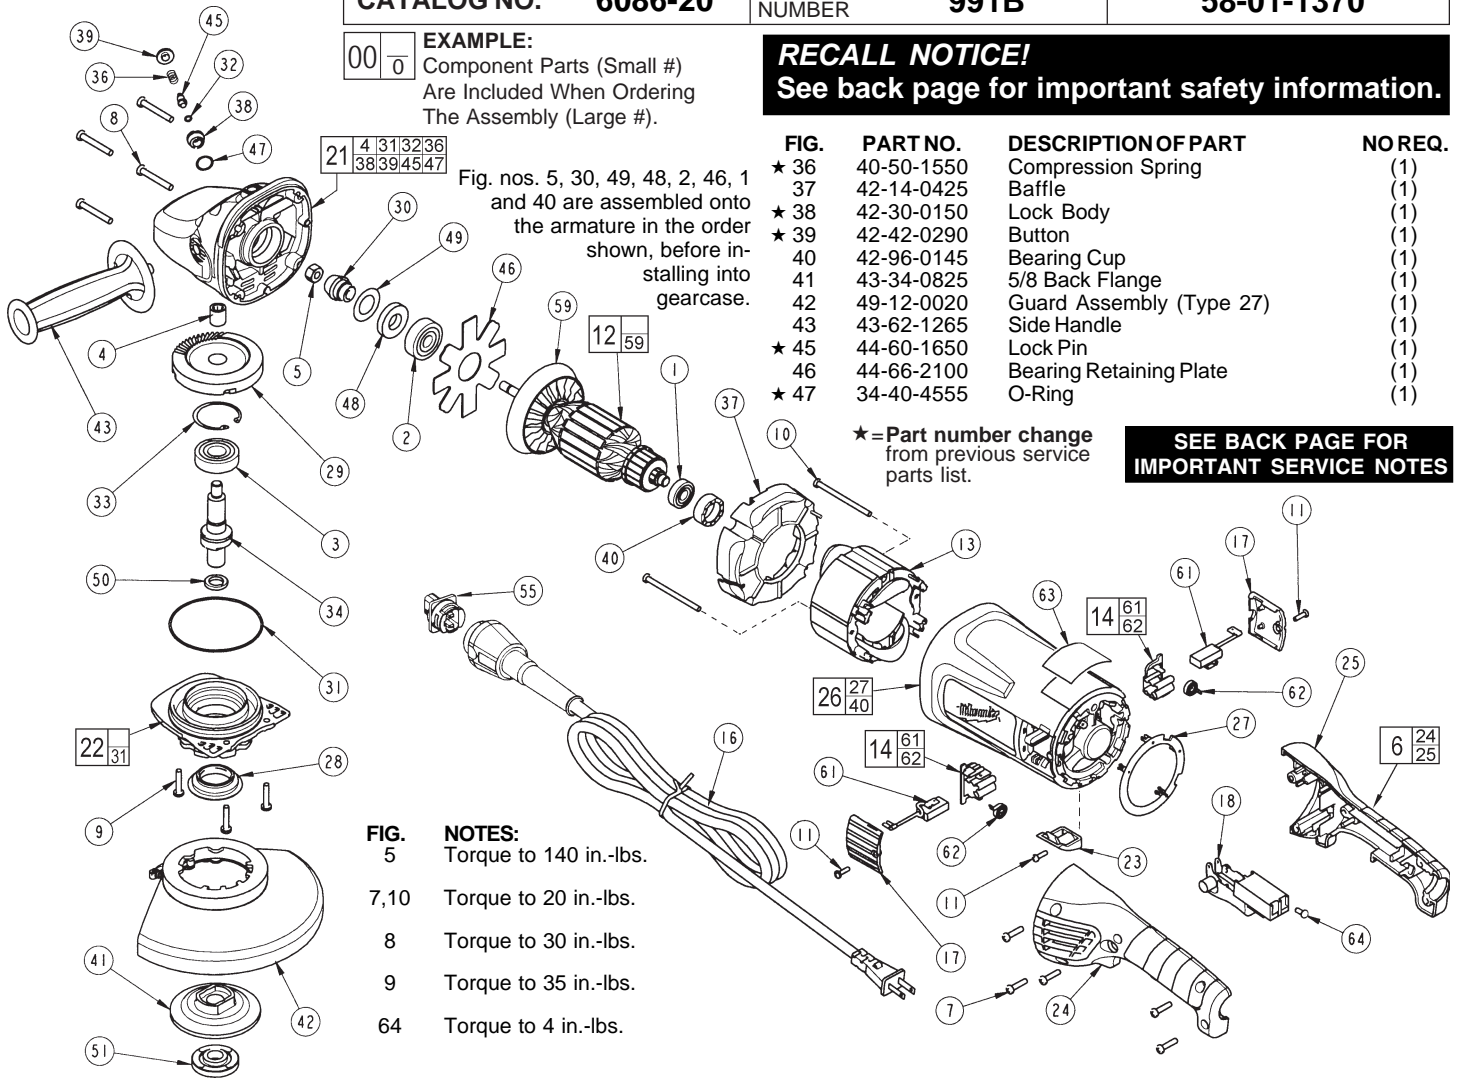
Fig. nos. 5, 30, 49, 48, 2, 46, 1 and 40 are assembled onto the armature in the order shown, before installing into gearcase.

- FIG. NOTES:**
- 5 Torque to 140 in.-lbs.
  - 7,10 Torque to 20 in.-lbs.
  - 8 Torque to 30 in.-lbs.
  - 9 Torque to 35 in.-lbs.
  - 64 Torque to 4 in.-lbs.

**FIG. LUBRICATION:**  
 21 1.25 oz. (35 grams) of Type "Y" grease, No. 49-08-5270 in main gear cavity of gearcase.
