SERVICE PARTS LIST

SPECIFY CATALOG NO. AND SERIAL NO. WHEN ORDERING PARTS M18 FUEL™ 1/2" Square Impact Wrench

2655-059

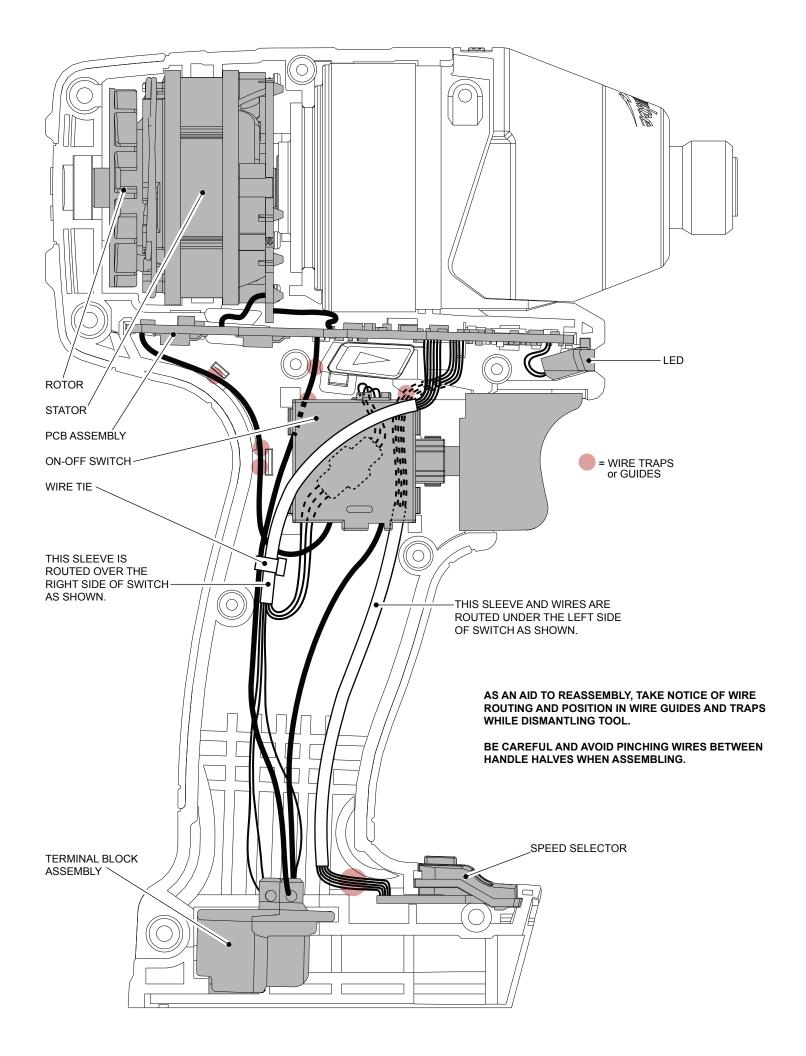
FIG.	PART NO.	DESCRIPTION OF PART	NO. REQ.
2	44-60-0597	Detent Pin	(1)
3	40-50-0925	Detent Spring	(1)
4	44-60-0465	Pivot Pin	(1)
9	45-88-2653	Plastic Washer	(1)
11c		1/2" Square Anvil	(1)
12	02-02-1300	5mm Steel Ball	(1)
19	02-02-0180	4.7mm Steel Ball	(2)
24		Ring Gear	(1)
25	44-66-2653	Gearcase End Cap with Ball Bearing	(1)
27		Stator Assembly	(1)
28	45-30-2653	Rubber Slug	(4)
34		PCBA	(1)
35	23-66-2653	On-Off Switch	(1)
36		Terminal Block Assembly	(1)
37	45-24-2653	Fwd/Rev Shuttle	(1)
38	40-50-1135	Spring	(1)
42	40-50-1090	Spring	(1)
43		Left Handle Halve	(1)
44		Belt Hook	(1)
45		Belt Hook Screw	(1)
46	06-82-2653	M3.5 x 8mm Pan Hd. Plastite Screw	(2)
47		Right Handle Halve	(1)
48		Service Nameplate (Not Shown)	(1)
49	42-55-2653	Carrying Case	(1)
50	06-82-7236	4-20 x 5/8" Pan Hd. Plastite T-10 Scr	(9)
56	14-30-2656	Gearcase Assembly	(1)
57	28-50-2654	Front Gearcase	(1)

FIG.	PART NO.	DESCRIPTION OF PART	NO. REQ.		
58	42-70-2653	Belt Clip Assembly	(1)		
59		Rotor Assembly	(1)		
60		Handle Assembly	(1)		
61	14-30-0095	Impacting Assembly	(1)		
62	14-20-2655	Electronics Assembly	(1)		
63	45-24-2655	Speed Selector	(1)		
66	42-06-0040	1/2" Square Anvil Assembly	(1)		
67	14-46-2654	Rotary/Handle Kit	(1)		
24,61	Lightly coat the I.D. of the ring gear (24) and the center of the planet gears of impacting assembly with grease.				
57	Coat inside of bushing inside front gearcase with grease.				
59	Coat pinion of rotor assembly (59) with grease.

Assembly going obsolete. Replaced by:				
= 14-20-2656 Electronics Assy.
